TECHNICAL NOTES

ENGINEERING – OK-8 (Rev.)

Re: Control of Trees and Brush on Dams

Control of Trees and Brush on Dams

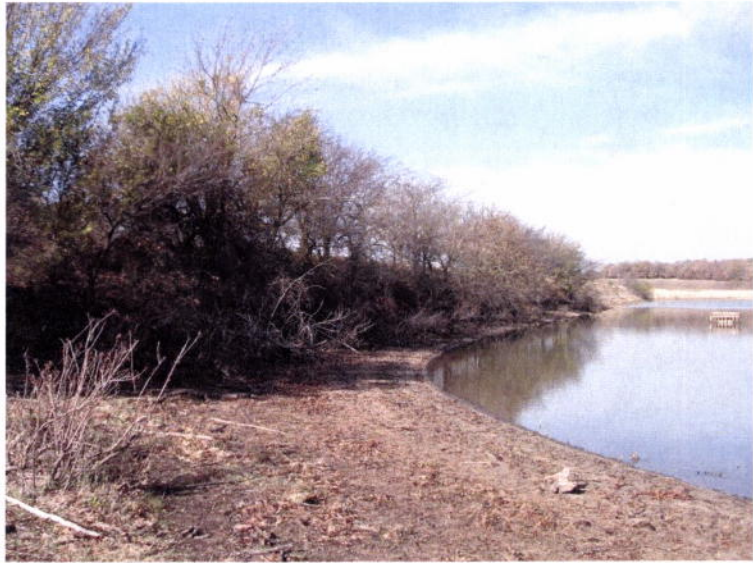
The following is a summary of the many potential problems that can be caused by trees growing on various sections of a dam:

A. Waterline

B. Front Slope, Crown and Upper Two-Thirds of the Back Slope

C. Lower One-Third of the Back Slope, Toe and 20 feet Beyond

D. Auxiliary Spillways
